## **GEOTECHNICAL INVESTIGATION**

**NEW SHOP BUILDING  
15880 KUGLEMAN STREET  
LOWER LAKE, CALIFORNIA**

**Project Number 13853.01**

**January 19, 2026**

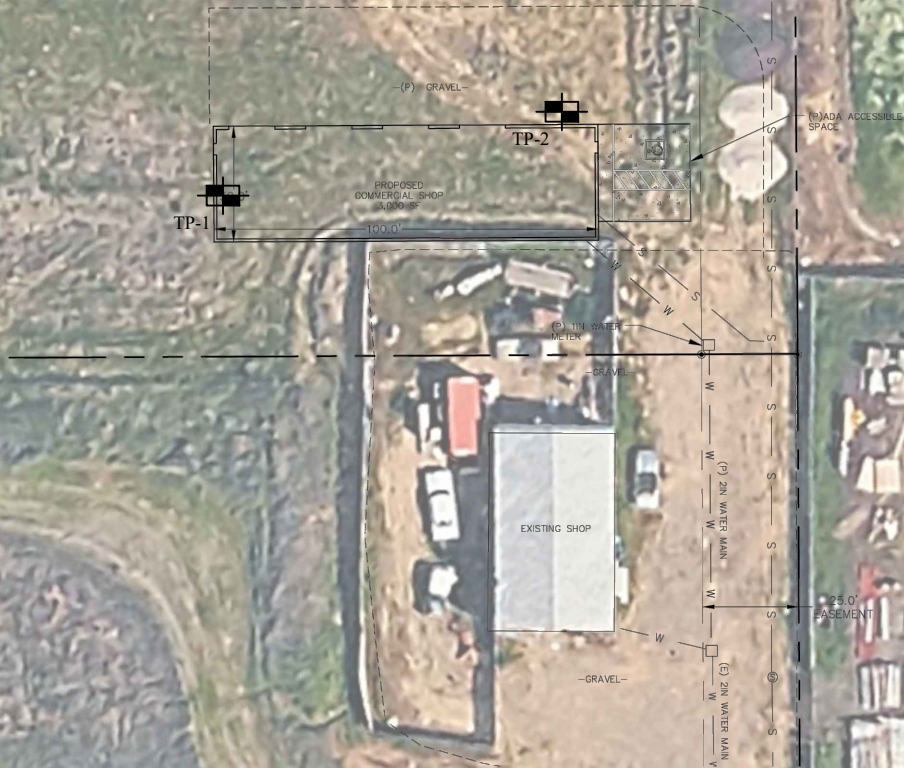
Test Pit location and number

Approximate property line

**REFERENCE:**  
 Google Earth and Plot Plan prepared  
 by VanDerWall Engineering dated  
 June 2025
